# Manhole Inspection Summary

Manhole # S37KK\_019MH

Insp Date: **3/20/07 11:45 AM**

**Location** Address: **401 NORTH AVE**

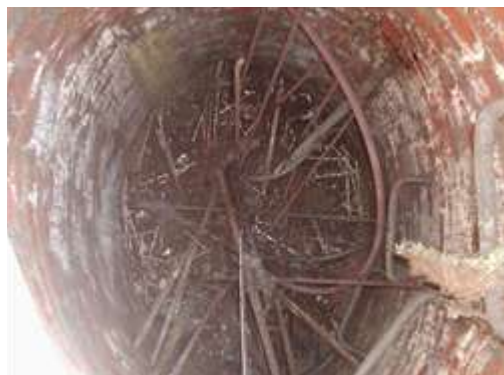
Top View

Adjustment and Barrel infiltration.  
Channel debris.

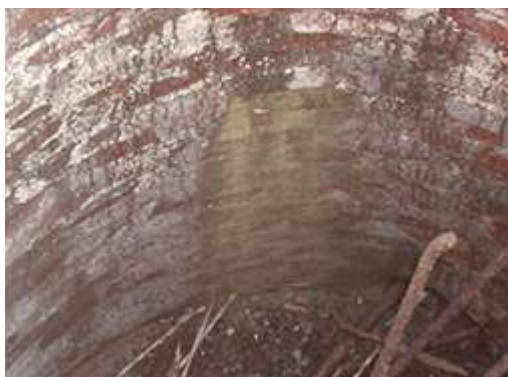
Defect

Barrel infiltration.

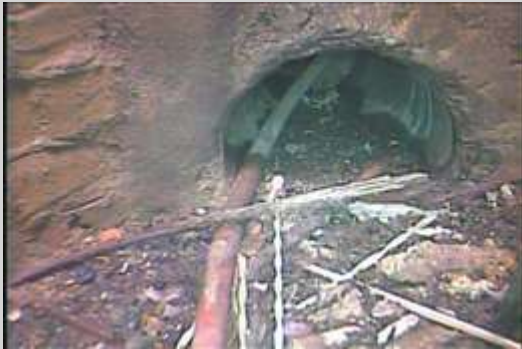
8 in. Circular Gravity Sewer  
Pipe Out @ 12 O'Clock

Deposits: ☐ None ☒ **Mud** ☐ Sludge ☒ **Debris** ☐ Grease

Silt Depth: **2** (in.) Deposits Extent: **Light**

Infiltration: **Evidence** Pipe Seal Cond: **Unknown**
